Phase I Environmental Site Assessment

Coach Lamp Corner Apartments

7216-38 Raytown Road
Raytown, Missouri 64133

Date Issued: November 20, 2013

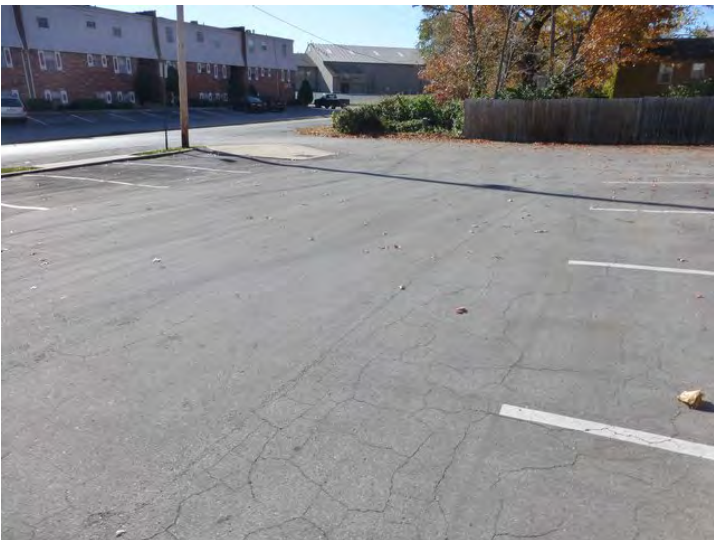
SLURRY COAT AND RESTRIPE PARKING LOT.

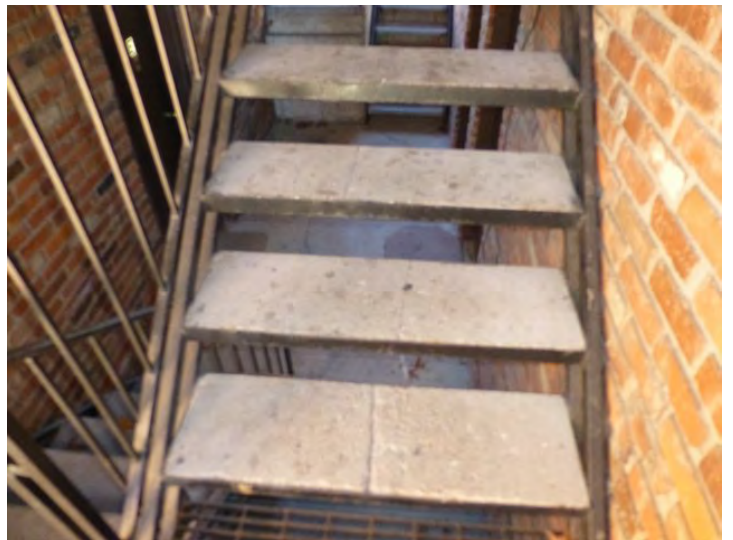
REPAIR DAMAGED TREADS AT BUILDING 7230.

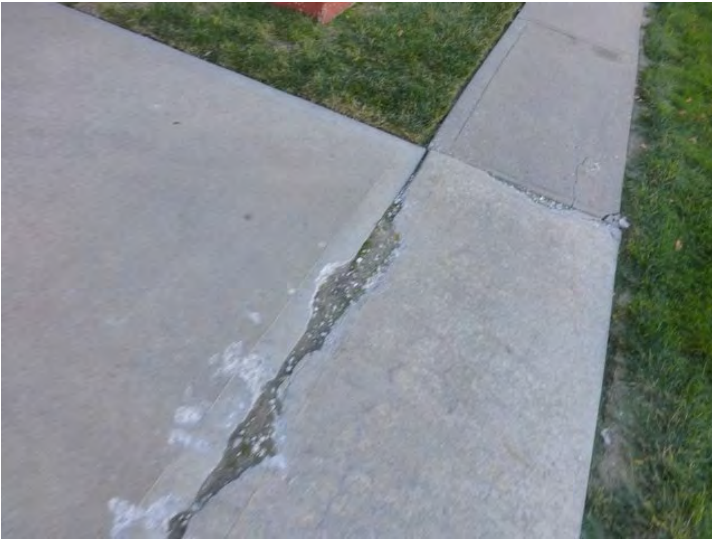
REPAIR SIDEWALKS.

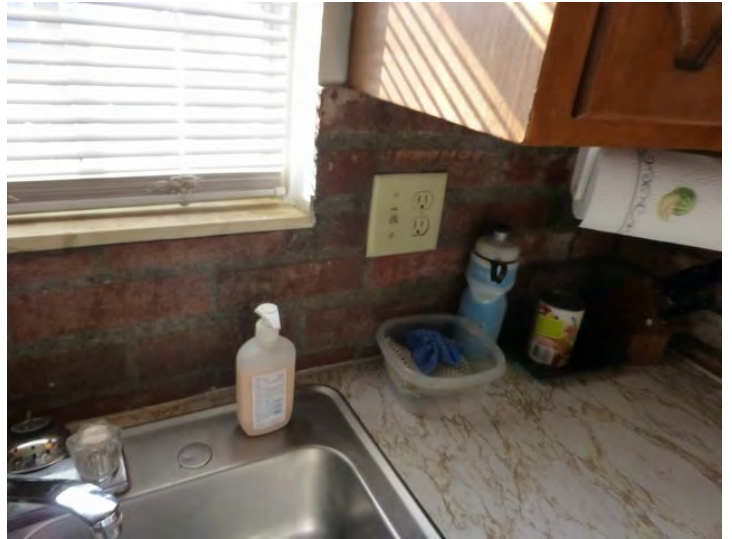
INSTALL GFCI OUTLETS.

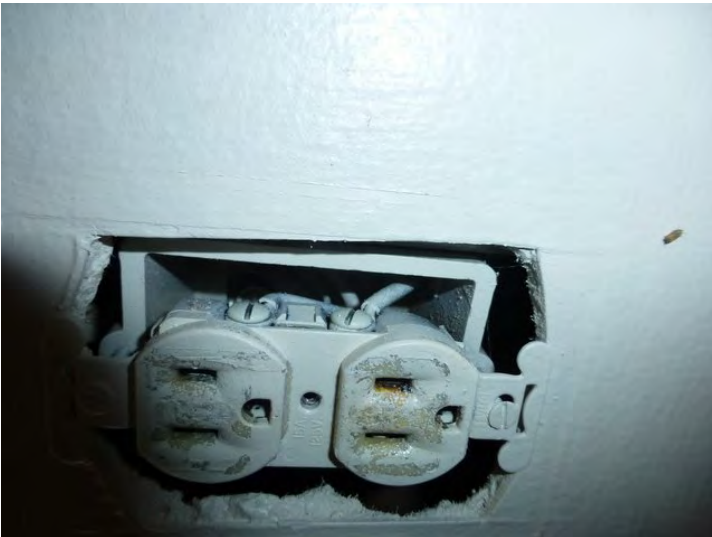
ALUMINUM WIRING.

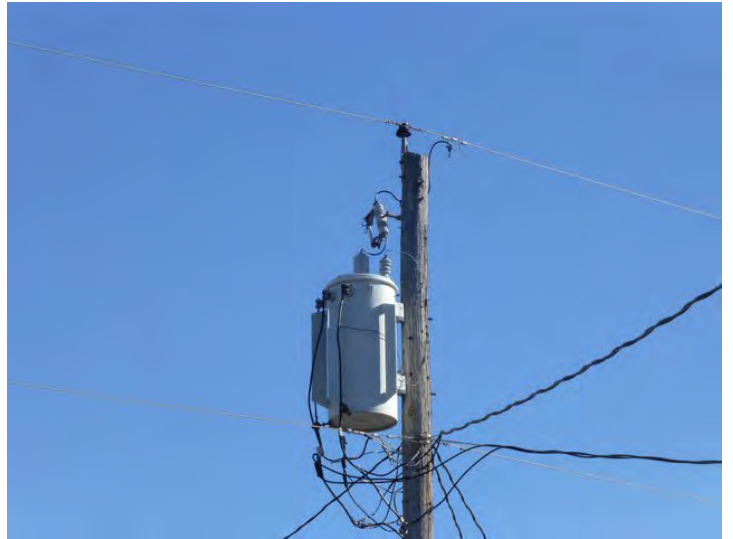
Visual inspection of the subject property reveals that the subject property is supplied electricity by Kansas City Power & Light (KCP&L) via approximately nine pole-mounted transformers located on-site. The visually inspected transformers did not show signs of leakage, and none were marked as PCB transformers.

POLE-MOUNTED TRANSFORMER.
