Phase I Environmental Site Assessment

The Raytown Village Apartments

7701-7717 Raytown Road
Raytown, Missouri 64138

Date Issued: November 20, 2013

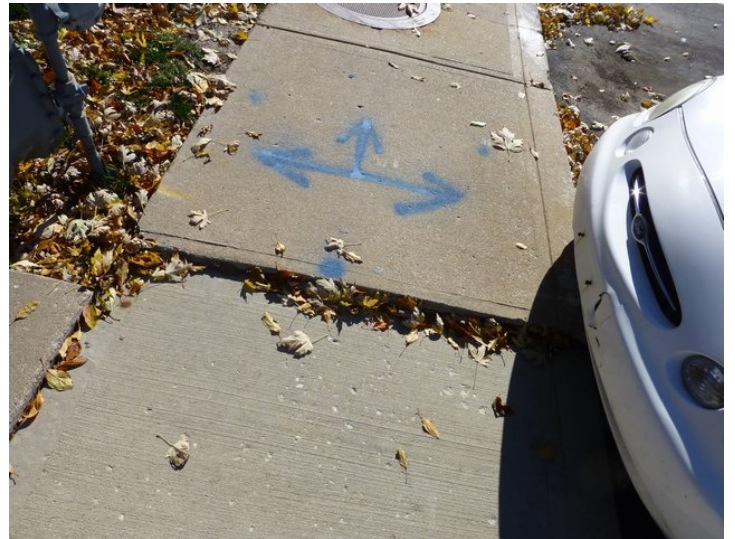
CORRECT TRIP HAZARD.

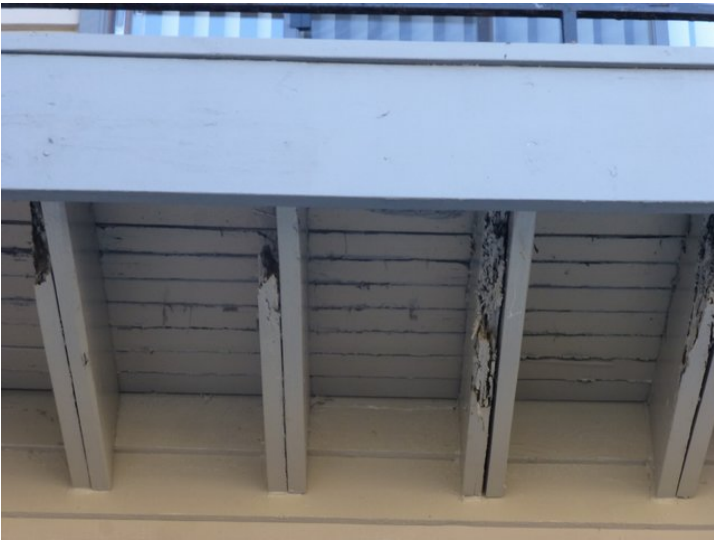
RECONDITION BALCONY SUPPORTS.

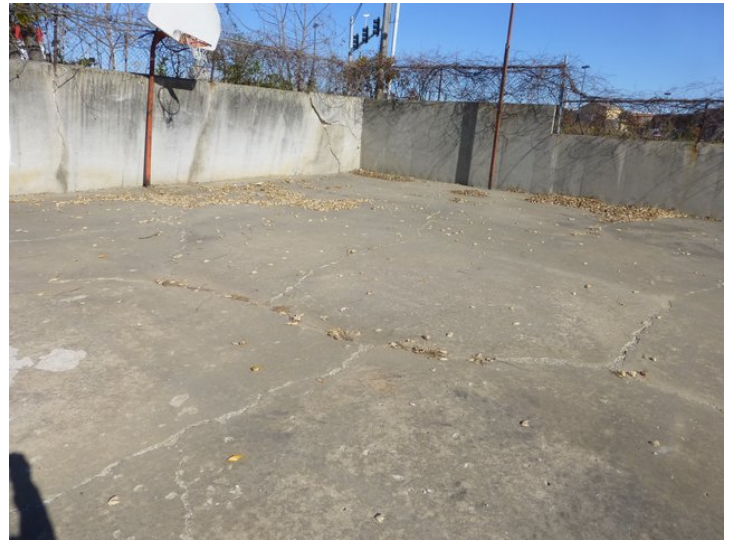
REPAIR BASKETBALL COURT.

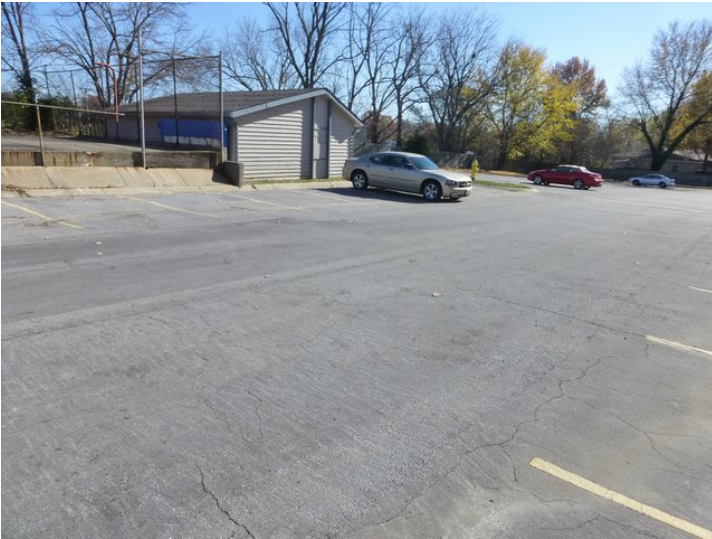
SEAL COAT AND RESTRIPE PARKING LOT.

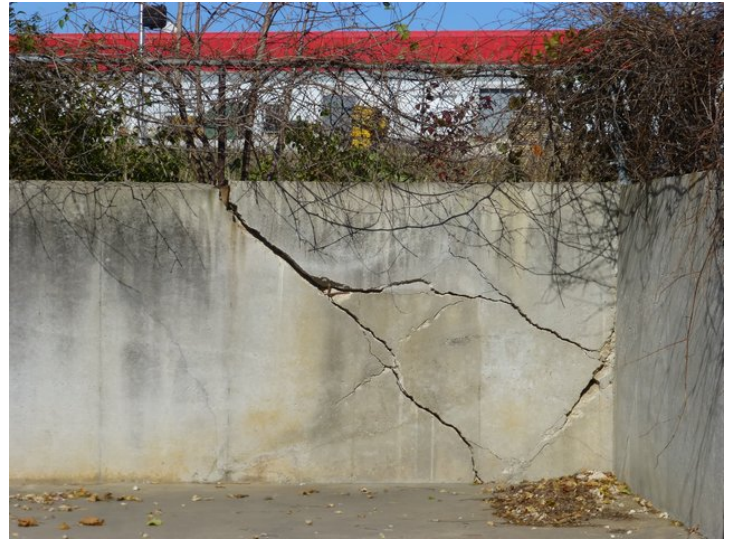
REPAIR RETAINING WALL NEAR BASKETBALL COURT.

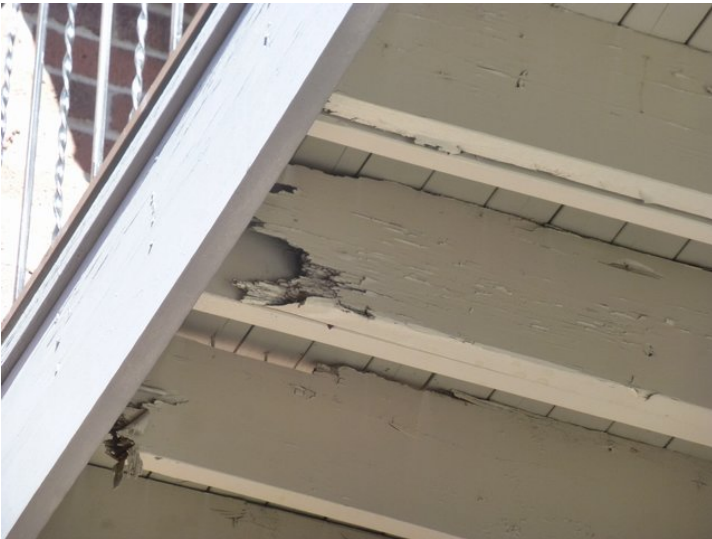
REPAIR BALCONIES.

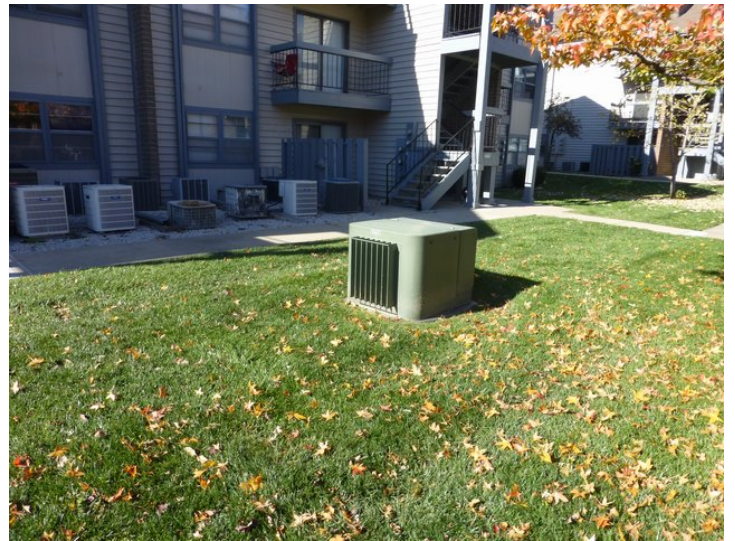
Visual inspection of the subject property reveals that the subject property is supplied electricity by Kansas City Power & Light (KCP&L) via approximately five pad-mounted transformers located on-site. Visual inspection of the transformers reveals that the transformers are owned by the electric utility, as evidenced by the ownership stickers affixed to the transformers. Additionally, visual inspection of the transformers did not indicate any leakage, and none were marked as PCB transformers.

PAD-MOUNTED TRANSFORMER.
